**[Docket No. FAA-2006-24074; Directorate Identifier 2005-NM-213-AD; Amendment 39-14676; AD 2006-14-05]**

**Airworthiness Directives; Bombardier Model CL-600-2C10 (Regional Jet Series 700, 701, and 702) Airplanes, Model CL-600-2D15 (Regional Jet Series 705) Airplanes, and Model CL-600-2D24 (Regional Jet Series 900) Airplanes**

**ACTION:** Final rule.

**2006-14-05 Bombardier, Inc. (Formerly Canadair):** Amendment 39-14676. Docket No. FAA-2006-24074; Directorate Identifier 2005-NM-213-AD.

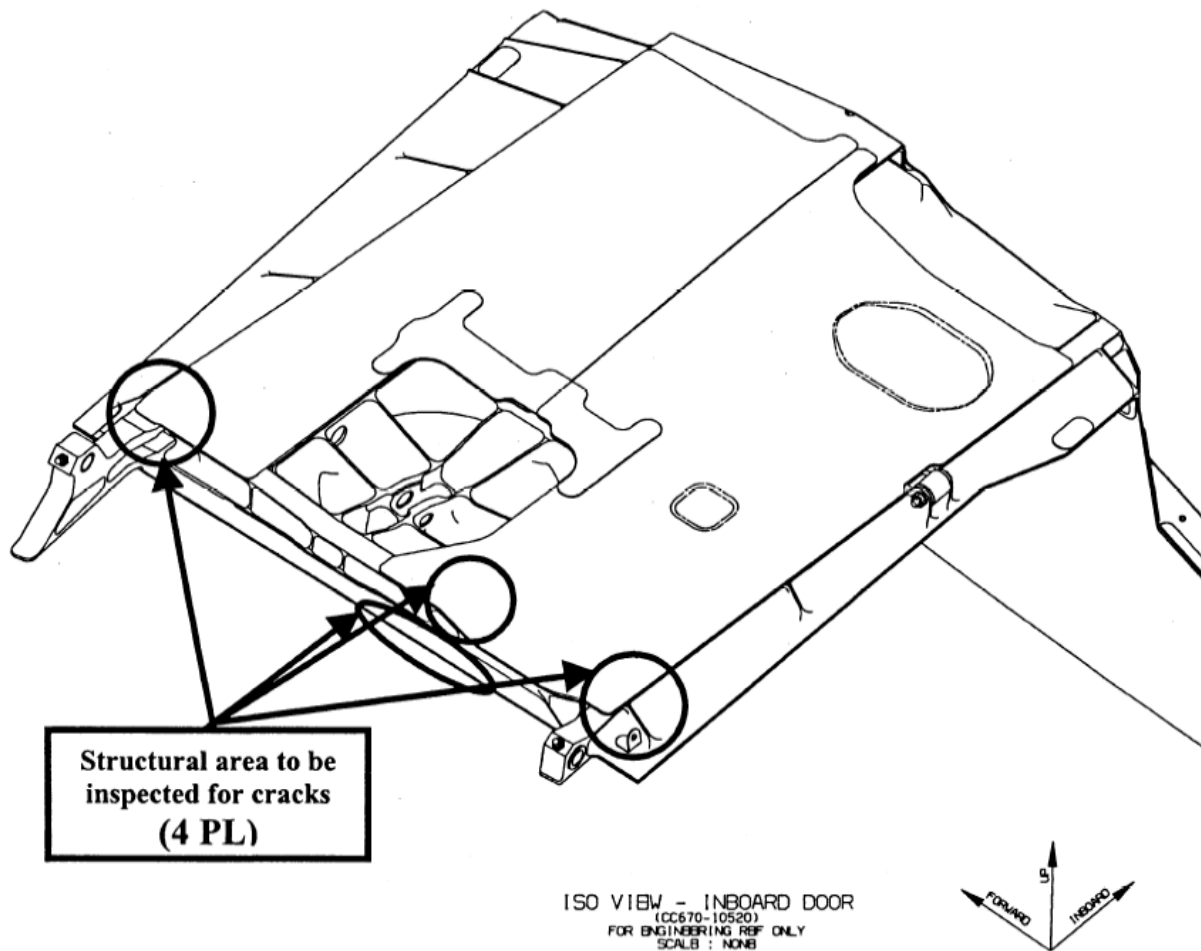
**Figure 1**  
LH side shown  
RH side opposite

(g) For Model CL-600-2C10 (Regional Jet series 700 & 701) series airplanes, S/Ns 10003 through 10999 inclusive; and Model CL-600-2D24 (Regional Jet series 900) series airplanes, S/Ns 15002 through 15990 inclusive: At the applicable time specified in paragraph (f) of this AD, perform detailed inspections of the lower panel, part number (P/N) CC670-10520, of the left- and right-hand MLG doors for the conditions and in the areas specified in paragraphs (g)(1), (g)(2), (g)(3), and (g)(4) of this AD; and Figures 1, 2, and 3 of this AD.

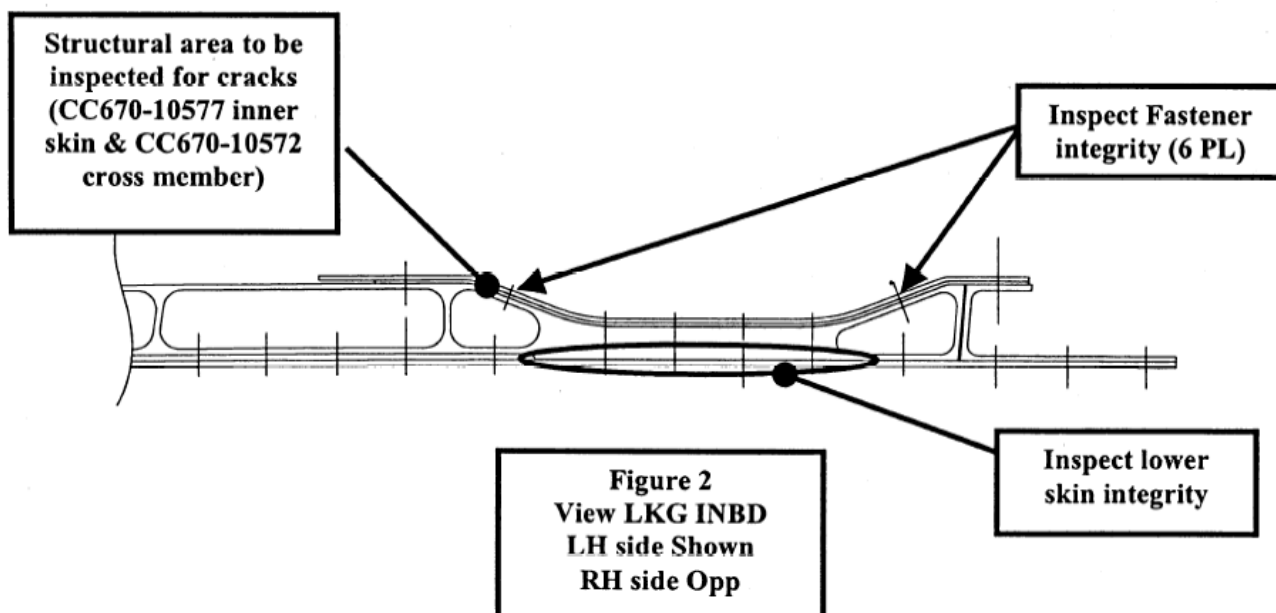
(1) Inspect the cross member, P/N CC670-10572, of the MLG door lower panel for cracking or deformation, in accordance with Figure 2 of this AD.

(2) Inspect the inner skin, P/N CC670-10577, of the MLG door lower panel at the cross member (P/N CC670-10572) for cracking or deformation, or pulled or missing fasteners, in accordance with Figure 2 of this AD.

(3) Inspect the outer skin, P/N CC670-10574, of the MLG door lower panel at the cross member (P/N CC670-10572) for cracking or deformation, or pulled or missing fasteners, in accordance with Figure 2 of this AD.

(i) If any cracking or deformation, or pulled or missing fastener, as applicable, is found during any inspection done in accordance with paragraph (g) or (h) of this AD: Before further flight, accomplish paragraph (i)(1), (i)(2), or (i)(3) of this AD.

(2) Replace the lower panel assembly, P/N CC670-10520, of the affected MLG door with a new or serviceable lower panel assembly having the same P/N, according to a method approved by either the Manager, New York ACO, FAA; or TCCA (or its delegated agent). Task Cards 32-12-01-000-801-A01 and 32-12-01-400-801-A01 of the CRJ 700/900 Series Regional Jet Aircraft Maintenance Manual are one approved method of doing the replacement. Repeat the inspections specified in paragraph (g) of this AD at intervals not to exceed 100 flight cycles.

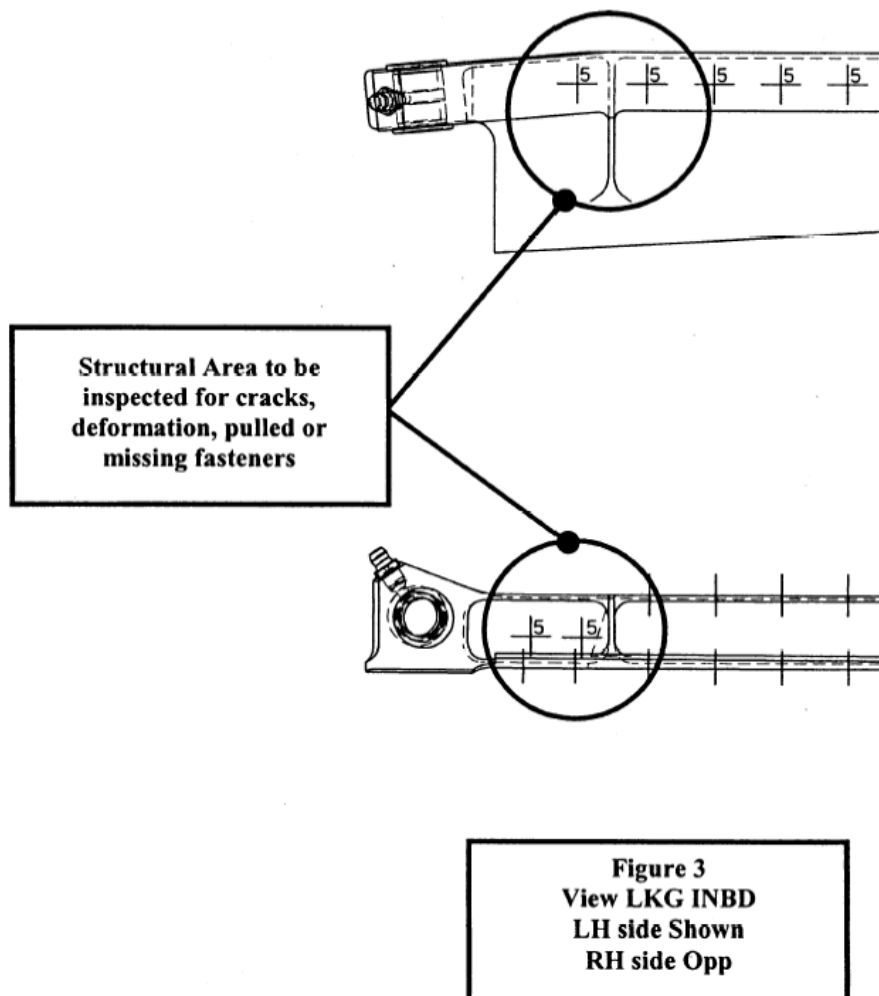
(4) Inspect the forward member, P/N CC670-10570, and aft member, P/N CC670-10571, of the MLG door lower panel for cracking or deformation, or pulled or missing fasteners, in accordance with Figure 3 of this AD. Figures 1 through 3 of this AD follow.
